Long-term Behaviour of Bare, Bolted Busbar Joints with and without the Contact Element, MC SEALconTACT

**Use of the contact element, MC SEALconTACT,
reduces electrical losses, prolongs service life and enhances
the reliability of the entire installation.**

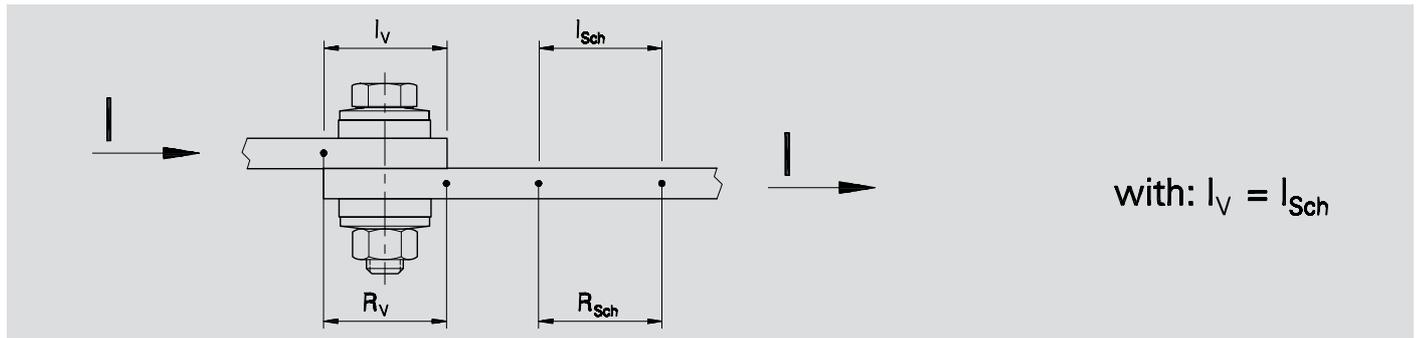
Figure 1

Joint resistance R_v and resistance factor k_u of bolted busbars

According to [1], the joint resistance R_v of a busbar joint, *Figure 1*, is the sum of several resistances as indicated by *Equation 1*.

$$R_v = R_b + R_e + R_f \quad (\text{Equation 1})$$

As indicated by *Equation 3*, the resistance factor k_u is the ratio of the joint resistance R_v over the overlap length l_v to the busbar resistance R_{sch} of a busbar of equal length l_{sch} .

$$k_u = \frac{R_v}{R_{sch}} = \frac{U_v}{U_{sch}} = \frac{P_v}{P_{sch}} \quad (\text{Equation 3})$$

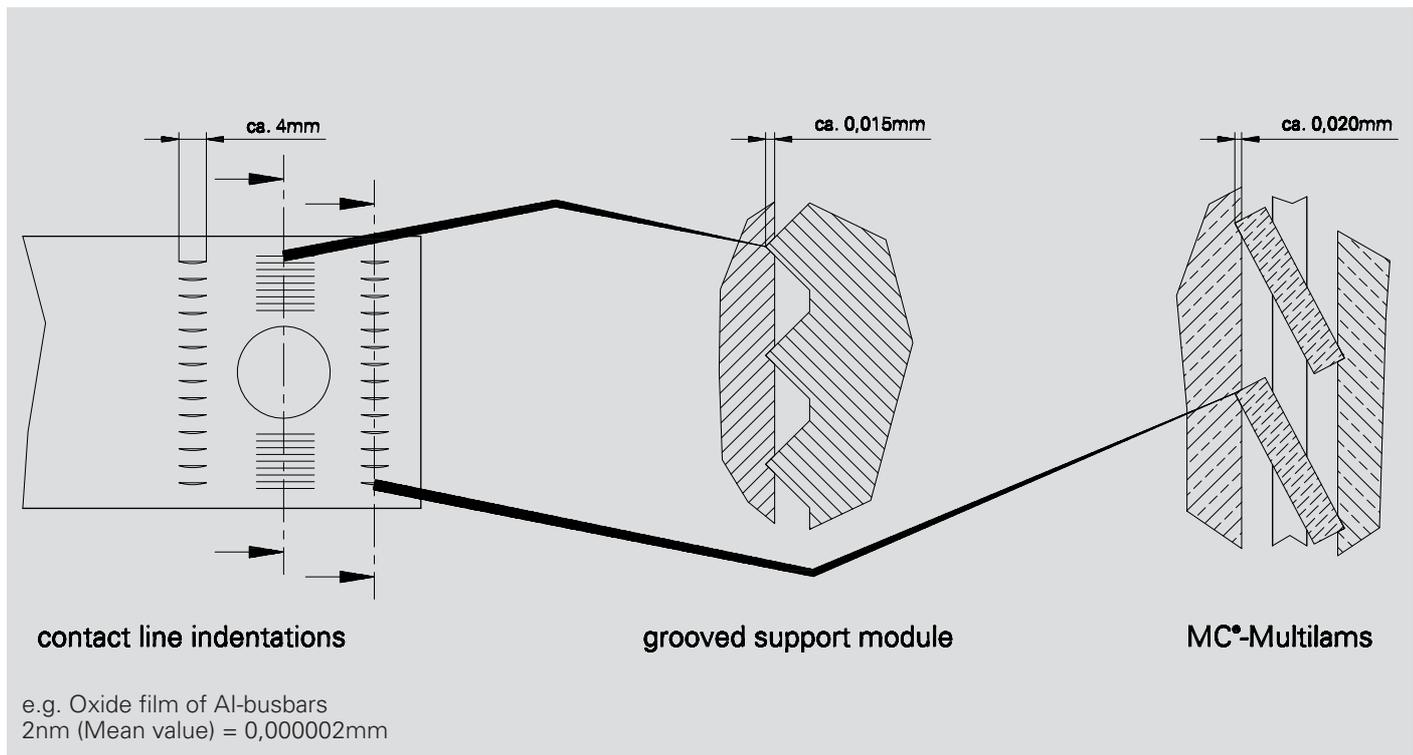
Figure 2
Penetration of the impurity film by the grooved support module and the MC Multilams

The support module's main function is to limit the compression of the torsion-spring louvers to ensure optimal contact. Providing the module with grooves adds an effect similar to that of the louvers themselves, namely that the peaks between the grooves break through the impurity films and bite into the busbars to ensure even contact between the two surfaces.

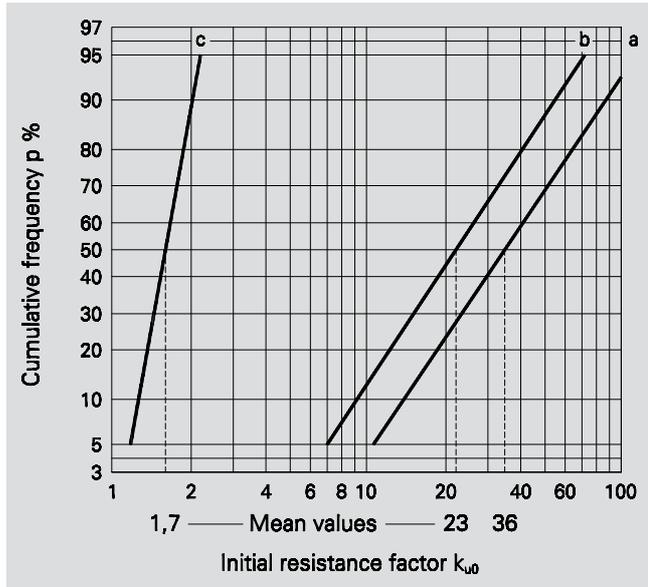
Figure 3
Empirically determined initial resistance factors k_{u0} of joints without MC SEALconTACT.

- Curve a: uncleaned
- Curve b: cleaned optimally and then touched by a dirty hand
- Curve c: cleaned optimally

Figure 3 presents figures for various surface pretreatment practices used to make up busbars joints without MC SEALconTACT.

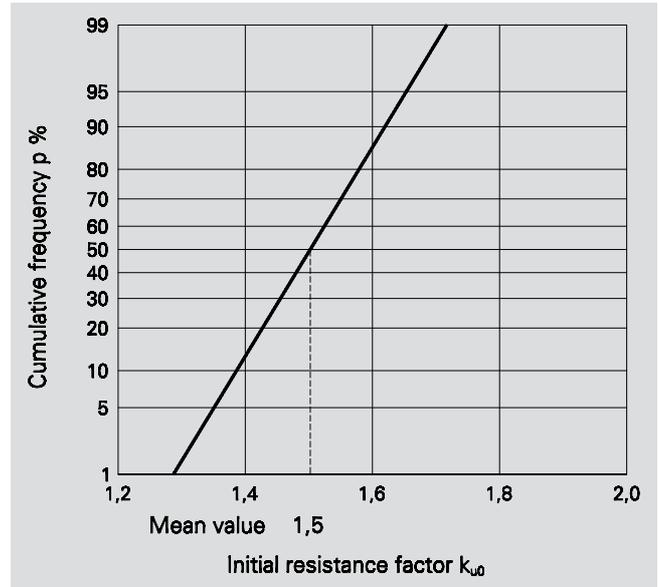
Figure 4
Empirically determined initial resistance factors k_{u0} of joints with MC SEALconTACT.

- > of cleaned and uncleaned busbars
- > Cu-Cu, Al-Al, Cu-Al
- > indoor duty, outdoor duty, exposure to rainwater

Figure 4 shows a virtually identical initial resistance factor of $k_{u0} = 1,5$ of busbars with MC SEALconTACTS for the material pairs Cu-Cu, Al-Al and Cu-Al, cleaned and uncleaned, indoor duty, outdoor duty, and exposure to rainwater.

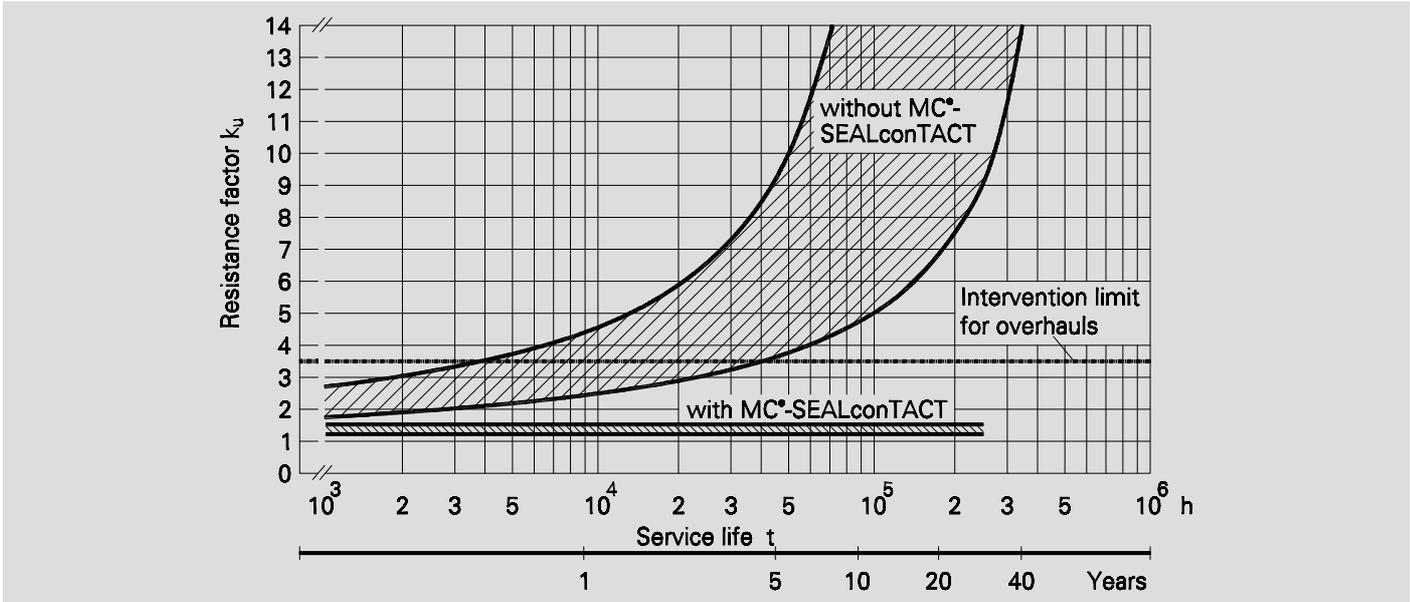
Figure 5
Long-term resistance factor $k_u(t)$

Investigations described in [2] demonstrate that the long-term resistance factor $k_u(t)$, as shown in *Figure 5*, depends largely on the initial resistance factor k_{u0} . Joints with high original resistance factors tend to become unstable fairly quickly. For instance, a joint with an original resistance factor of $k_{u0} = 6$ may fail totally in a matter of months.

Shown in *Figure 5*

The curves were determined experimentally [2] for indoor applications. The bandwidth between the two curves was determined by two different variables:

- different initial resistance factors k_{u0}
- different temperature combinations

If the electrical loss costs are to be minimized or kept at an economically justifiable level, the joint should be overhauled as soon as its resistance factor k_u reaches 3,5.

These curves apply to both indoor and outdoor applications. The forecast long-term behaviour is based on extensive environmental simulations employing accelerated ageing (Appendix) and on the functional properties of MC® torsion-spring louvers as determined by many years of actual service. In outdoor applications, the sealing frame of the contact and support modules is doubly important.

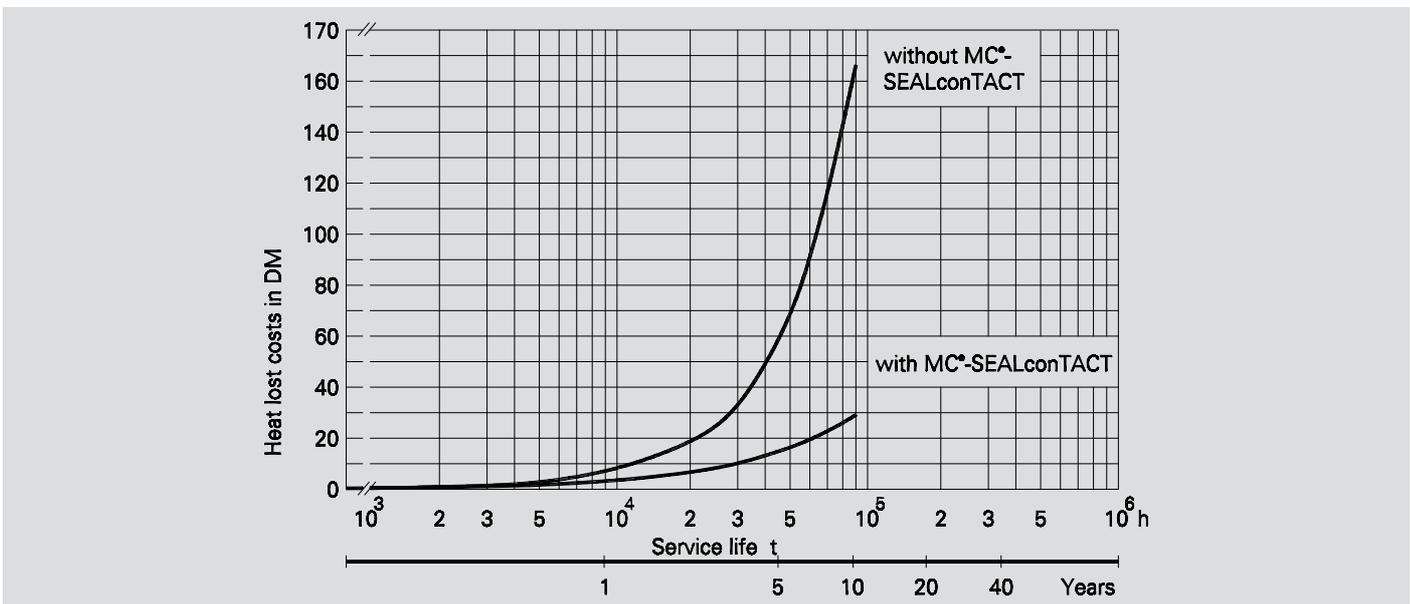
Figure 6
Prospective energy cost savings achievable with the contact element, MC SEALconTACT

Figure 6 shows the comparative costs of the heat losses caused by the contact resistance R_c . The curves do not include the heat losses in the busbars caused by the internal resistance R_b . The calculations are based on a busbar joint that occurs very frequently in power distribution systems.

Busbar material:	aluminium, bare
Dimensions:	40mm x 10mm
Current:	600A, constant
Initial resistance factor k_{u0} :	1,5
Long-term resistance factor $k_u(t)$:	averages from <i>Figure 3</i>
Service period:	up to 10 years
Energy price:	€ 0.08 / kWh
